## Evidence for Aquifer and Slurry Line Contamination and Land Subsidence From Vivian Silica Sand Extraction Wells

by D.M. LeNeveu, M.Sc. (biophysics), B.Ed., B.Sc. (hons. physics)  
February 2021  
Prepared for What the Frack Manitoba

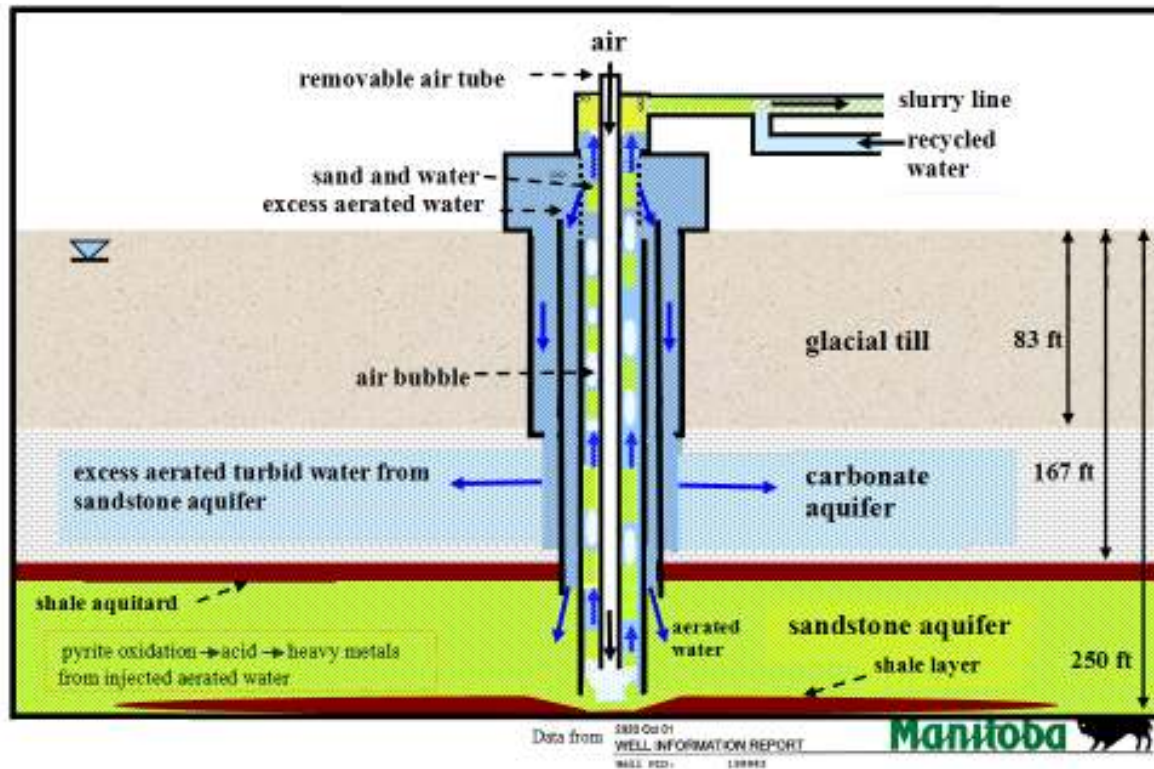
**Figure 2.** Aquifer and slurry water contamination scenario from interpretation of CWS well drilling record ID 199982 obtained from Manitoba Groundwater Section.

Figure 2 illustrates the scenario for aquifer and slurry water contamination and unsustainable draw on the sandstone aquifer for well PID 199982 at Centre Line Road.

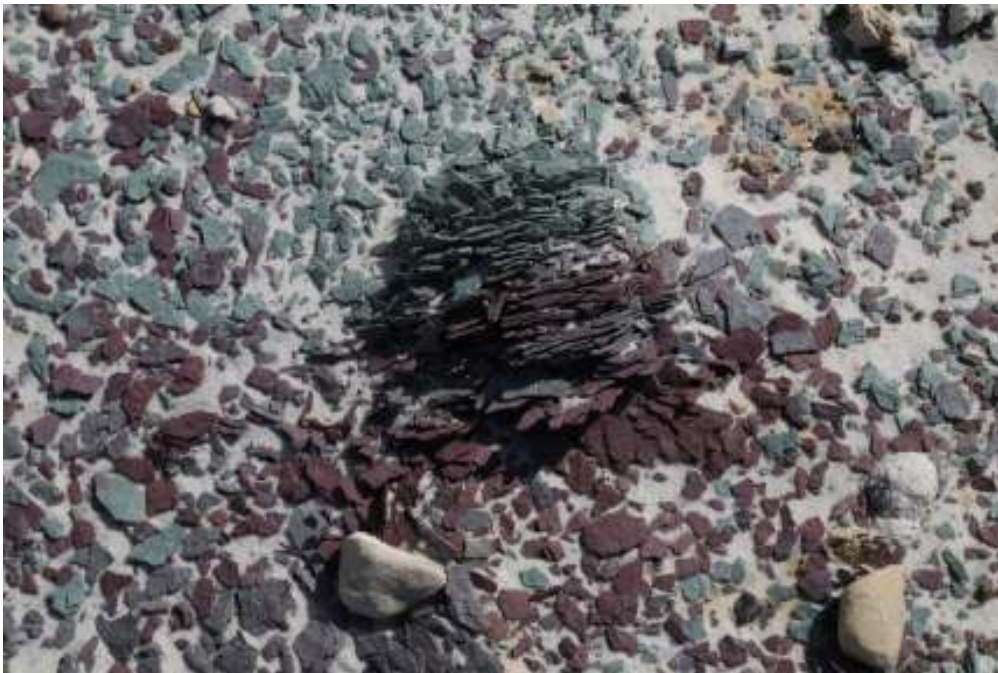
**Figure 3.** Shale fragments interspersed in CWS extracted sand near Vivian Manitoba

The sandstone formation from which the sand is to be extracted is known to have sources of pyrite. In a wet environment, pyrite will react with air to form acid.<sup>3,4,5</sup> The acid can mobilize heavy metals causing contamination. This is a well known problem in mining called acid drainage.<sup>5</sup> The brief disclosure in the CWS EAP of air injection to the aquifer is gravely concerning. I described in my submission to the Manitoba public review of the CWS processing facility, how the injection of air would react with the pyrite in the formation causing heavy metal contamination of the aquifer.<sup>12</sup> I reported that shale fragments and pyritic oolite was observed by local residents in sand piles near Vivian extracted by CWS during advanced exploration activities as shown Figure 3.

The configuration of triple tube air lift extraction well of Figure 2 and Figure 5 does not conform to the description in Mr. Somji's letter to the IAAC of Sept. 11, 2020. The outside diameter of the extraction well tube is given as 24 inches, much larger than the outside diameter of 25 cm. (9.8 inches) given in Mr. Somji's letter. The inner 16 inch diameter steel tube of well 199982 extends into a red shale layer. Red shale fragments from the hole drilled six feet into the red shale layer are likely to be extracted with the sand. Shale fragments have been observed in the CWS extracted sand piles by local residents as shown in Figure 3.

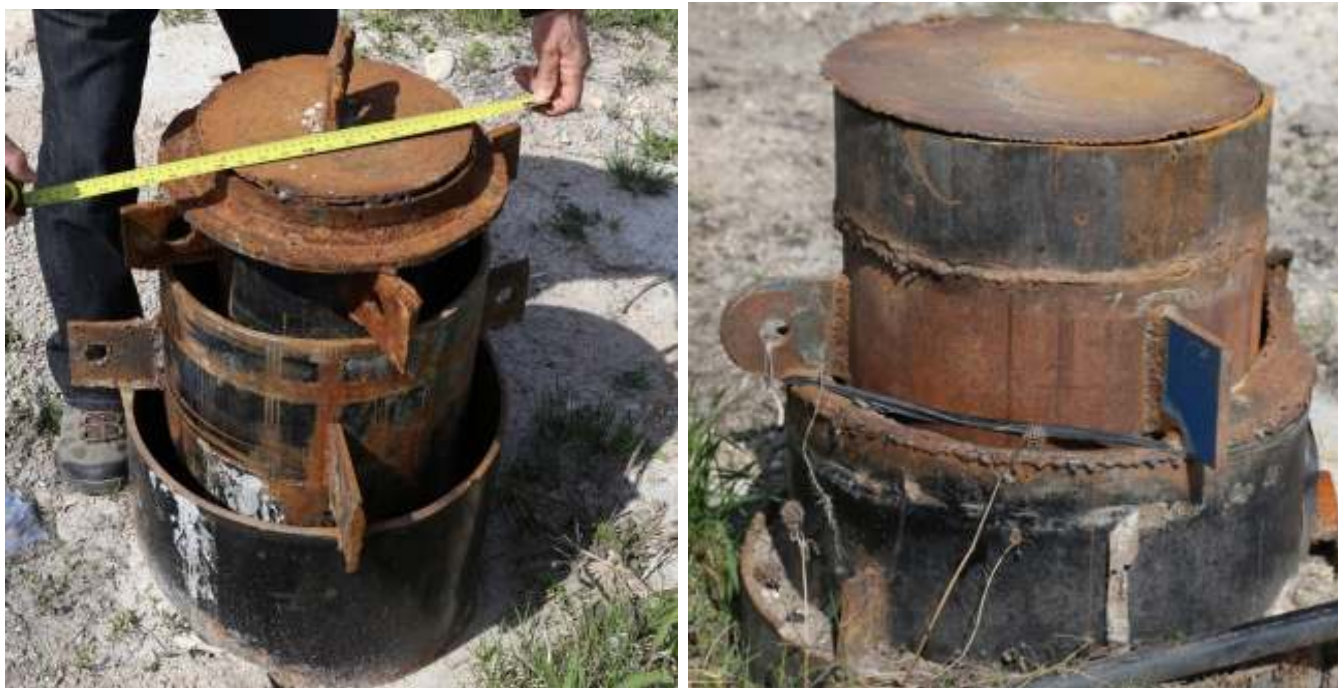
**Figure 6.** CWS triple tube air extraction well 199982/002472 at Centre line Road site and an unidentified well Centre Line Road showing visible surface sealing between the outer casing and the adjacent inner casing.

Note that sealing of well 199982/002472 did not occur until June 18, 2020, almost two years after completion in September 28, 2018. Sealing outside the external casing and inside the tubes did not appear to occur until June 18, 2020 according to the records. The fact that the three tubes remained open and unsealed until the sealing date of June 18, 2020 is verified by the photograph of Figure 6 taken May 31, 2020. The surface of the water table was visible inside the unsealed tubes. An unidentified well with no well tag and visible surface sealing between the outer and adjacent steel casing is also shown in Figure 6 at the Centre Line Road site. The photograph of the unidentified second well of Figure 6 verifies that if well 199982 had annular sealing between the steel casings, it would have been visible.

The casings for well 199982/002472 were cut off two feet below ground upon sealing on June 18, 2020. Combining the sealing report and the well construction report long after the completion of the well is a violation of the Manitoba Groundwater and Water Well Act.<sup>13</sup> This violation makes it impossible to determine when the annular sealing between the triple tube casings was emplaced by means of the well information report. The well photograph, witness accounts and a photograph of another well with annular sealing between the outer and adjacent steel tubes establishes that the annular spacing between steel casing in well 199982 were open and functional at the time of sand extraction.

Well 199982 had no affixed well tag. The well was identified as PID 199982 WINT 0002472 by the unique triple tube diameters in the well records that match the measurement shown in Figure 5. Both wells shown in Figure 6 as well as many others at the Centre Line Road site were left improperly covered. Mr. Somji in his letter to the IAAC of Sept. 11, 2020 claimed that vandalism occurred on CWS unattended drill sites. Figure 6 shows the cover for the inner tube was partially welded on. Specialized equipment such as a cutting torch would have been required to remove well covers over the outer well tubes. Attributing the lack of proper covering of the well to vandalism is not credible. Inadequate well covering and failure to affix well tags are violations of Well Standards Regulation 21/2015 of the Manitoba Groundwater and Water Well Act.<sup>13</sup>

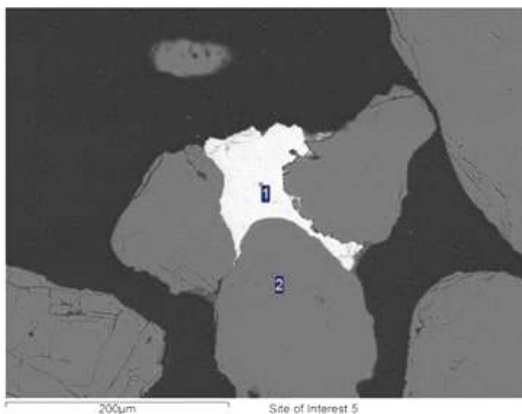
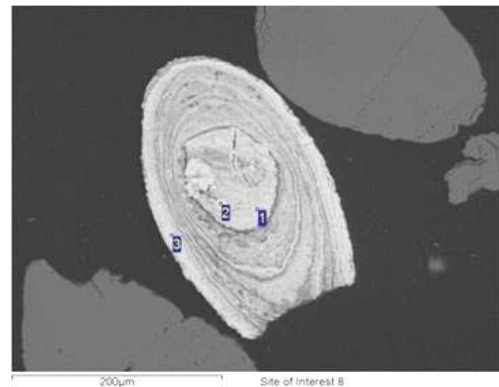
**Figure 8.** Electron microscope pictures of marcasite (a form of pyrite) between sand grains from the Winnipeg Formation near Seymourville.

The sand taken from the Winnipeg formation near Seymourville was found to contain marcasite a form of pyrite. The marcasite found at Seymourville is consistent with the paper by Schieber and Riciputi (2005) on the diagenesis of marcasite throughout the Winnipeg formation. The same process for marcasite diagenesis during the Ordovician era would be expected to occur in the sandstone throughout the CWS claim area. The marcasite in the sand is shown in microscope pictures from the 2014 NI 43-101 technical report of Claim Post Inc. reproduced in Figure 8.<sup>7</sup>

Figure 17: Backscattered Electron Image of Master Composite 6 Minutes Non-Mag -50/+70 Mesh  
Quartz grains (grey) are cemented together by pyrite/marcasite (white).

Figure 18: Backscattered Electron Image of Master Composite 6 Minutes Non-Mag -50/+70 Mesh  
Rounded pyrite/marcasite grain exhibits concentric layering.

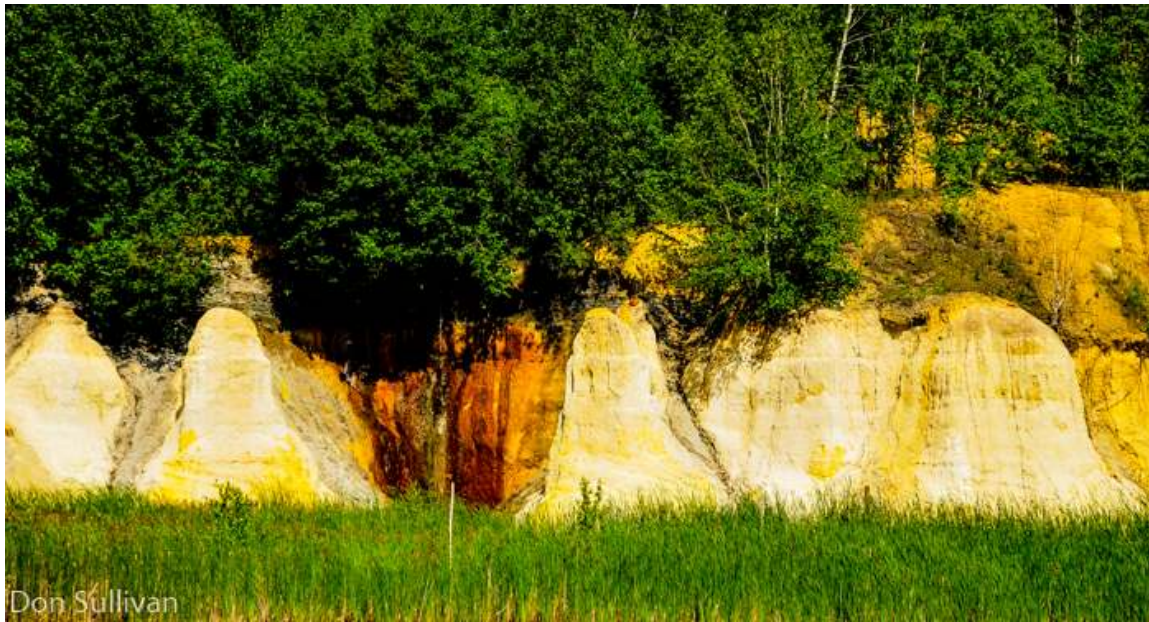
In the abandoned quarry on Black Island Manitoba silica sand was mined from the Winnipeg Formation since the 1920's. Oxidation of the pyrite in the shale layer overlying the white sand can be clearly seen on the excavation faces of the abandoned quarry to this day as shown in Figure 11. Litmus paper shows the seepage from the excavation faces is acidic with a pH of about 6 as shown in Figure 12. These field results demonstrate the bicarbonate naturally occurring in the sandstone is insufficient to neutralize the acid formed from pyrite oxidation. Phipps et al. (2008) reported the bicarbonate concentration over a wide area including near Black Island ranges from 226 to 532 mg/L with a median concentration of 346 mg/L similar to the concentration in the area around Steinbach.<sup>35</sup>

**Figure 11.** Acid drainage from excavation faces of the Winnipeg Formation sand overlain by shale at Black Island. The picture was taken by Don Sullivan Aug. 3, 2020

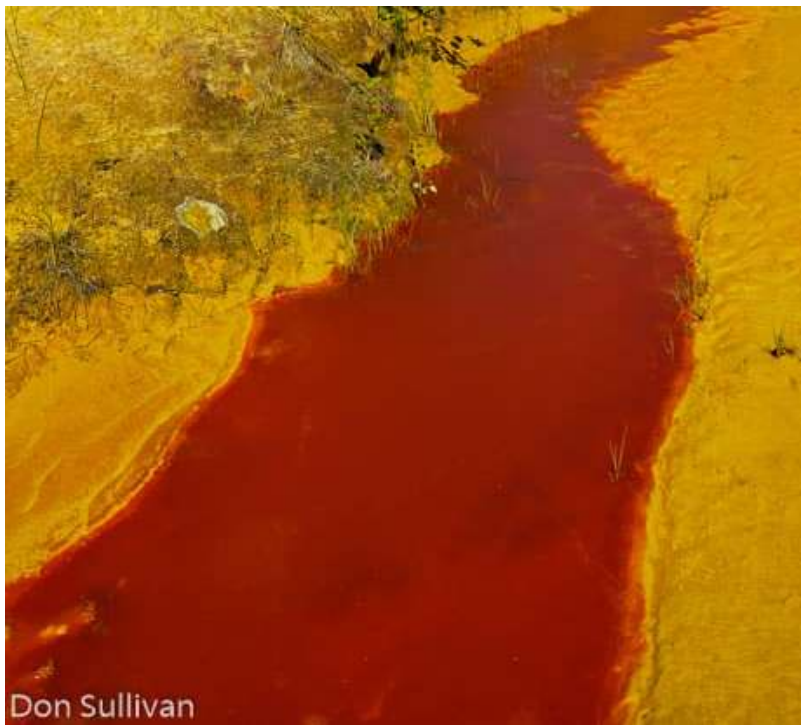
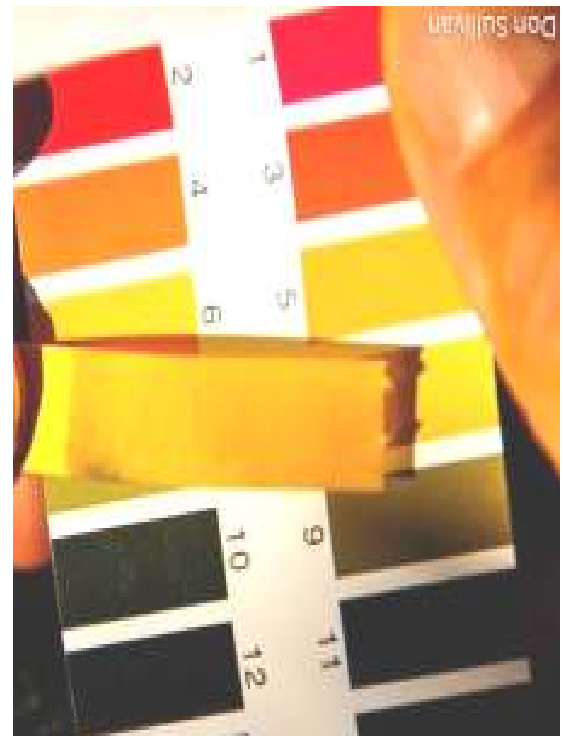
**Figure 12. a. and b** Hematite coloured water from acid drainage from Winnipeg Formation sand and overlying shale in the abandoned quarry pit at Black Island and litmus paper test showing acidic water from pyrite dissolution at Black Island after almost 100 years of leaching. The pictures were taken by Don Sullivan Aug. 3, 2020. The pH test was witnessed by Don Sullivan.

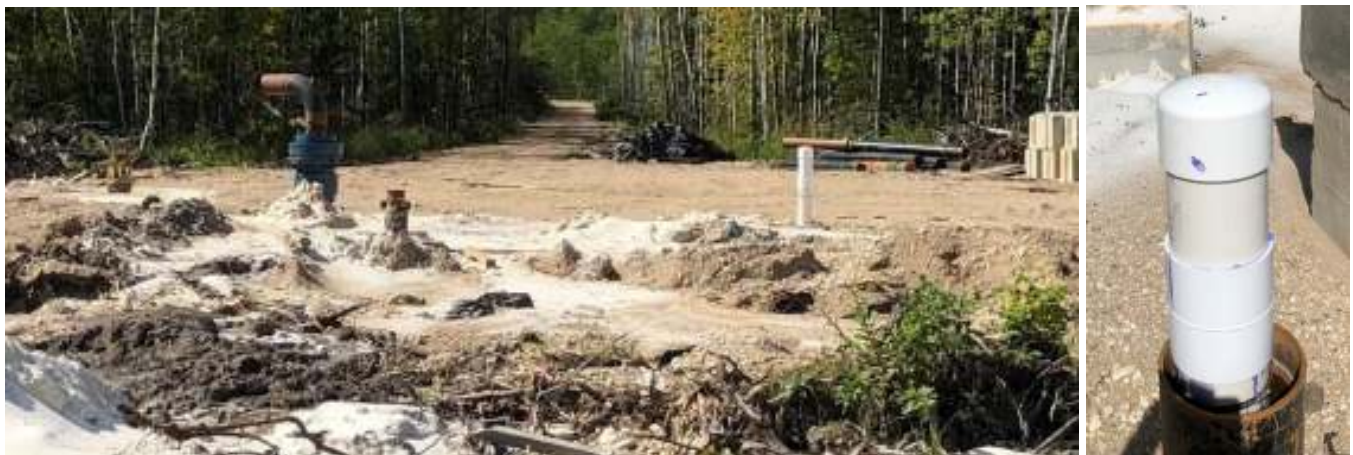
Five CWS wells with PID/ well tag numbers 201401/002447, 201400/002445, 201399/002446, 201159/02521 and 201398/02444 were completed June and July 2019 south of the town of Vivian at the location of the proposed Vivian Sand Processing Facility. The five wells are shown in Figure 13.

**Figure 13.** Five wells at SE32-10-8E south of Vivian MB completed June to July 2019. The well tag numbers (WINT) numbers from left to right are 002447, 02445, 02446, 02521 and 02444

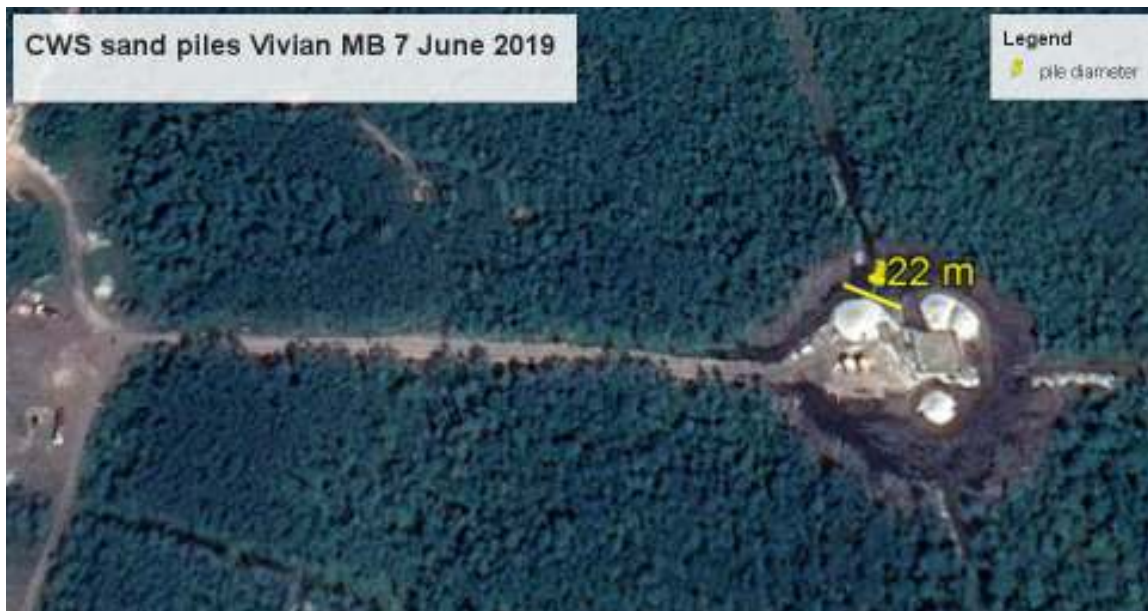
A Google earth image shown in Figure 14, taken June 7, 2019 the date of completion of well 201399 at Vivian, shows that water was discharged around the sand piles. The other four wells were not completed at this time. Google Earth image shows excess water was discharged around the sand piles consistent with well 201399 not being designed to discharge excess water into the formation.

**Figure 14.** Discharged water around sand piles extracted by CWS air lift wells near Vivian Manitoba

The discharge water could have contained heavy metals and acid from the oxidation of marcasite and shale fragments in the extracted sand and from oxidation of marcasite and pyrite in the sandstone formation from return of aerated excess water. Laboratory reports for samples of the extracted sand collected by local residents show the sand was coated with marcasite consistent with the NI 43-101 report for sand at Wanipigow and a literature report describing the diagenesis of marcasite in the Winnipeg Formation.<sup>6,27</sup> Leaching of heavy metals and acid could have occurred from rainfall on the sand piles. The lower content of sulphide measured in weathered sand at Vivian compared to the sulphide content of fresh sand from Wanipigow provides evidence that marcasite oxidation occurred. (See Figure 9 and Figure 10) The contamination from the sand piles and CWS well water discharge may have seeped into the water table and eventually migrated to the Brokenhead River or the carbonate aquifer.

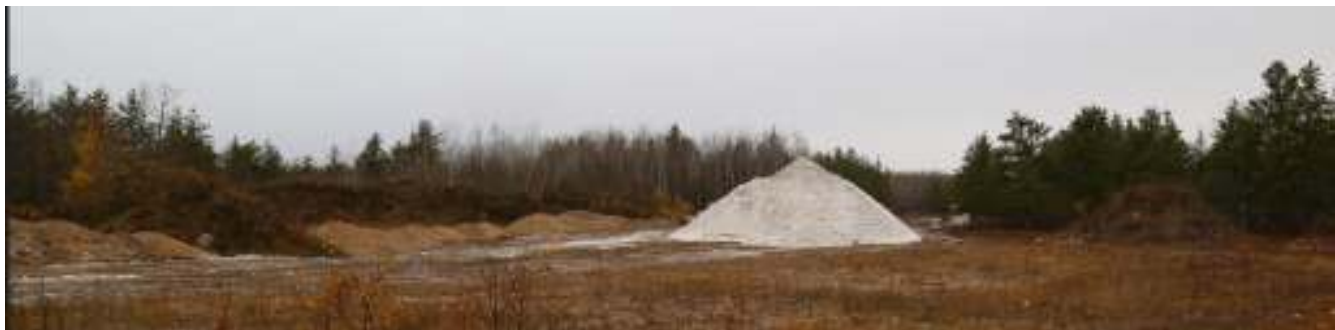
We suspect that such a large perturbation to the aquifer would have contributed to the continuing well water problems experienced by residents of Vivian. A silica sand pile extracted at the quarry site in October of 2020 near Vivian is shown in Figure 16.

**Figure 16.** Silica sand extracted by CWS at a quarry near the junction of Highway 15 and 302 within one kilometre of Vivian, Manitoba

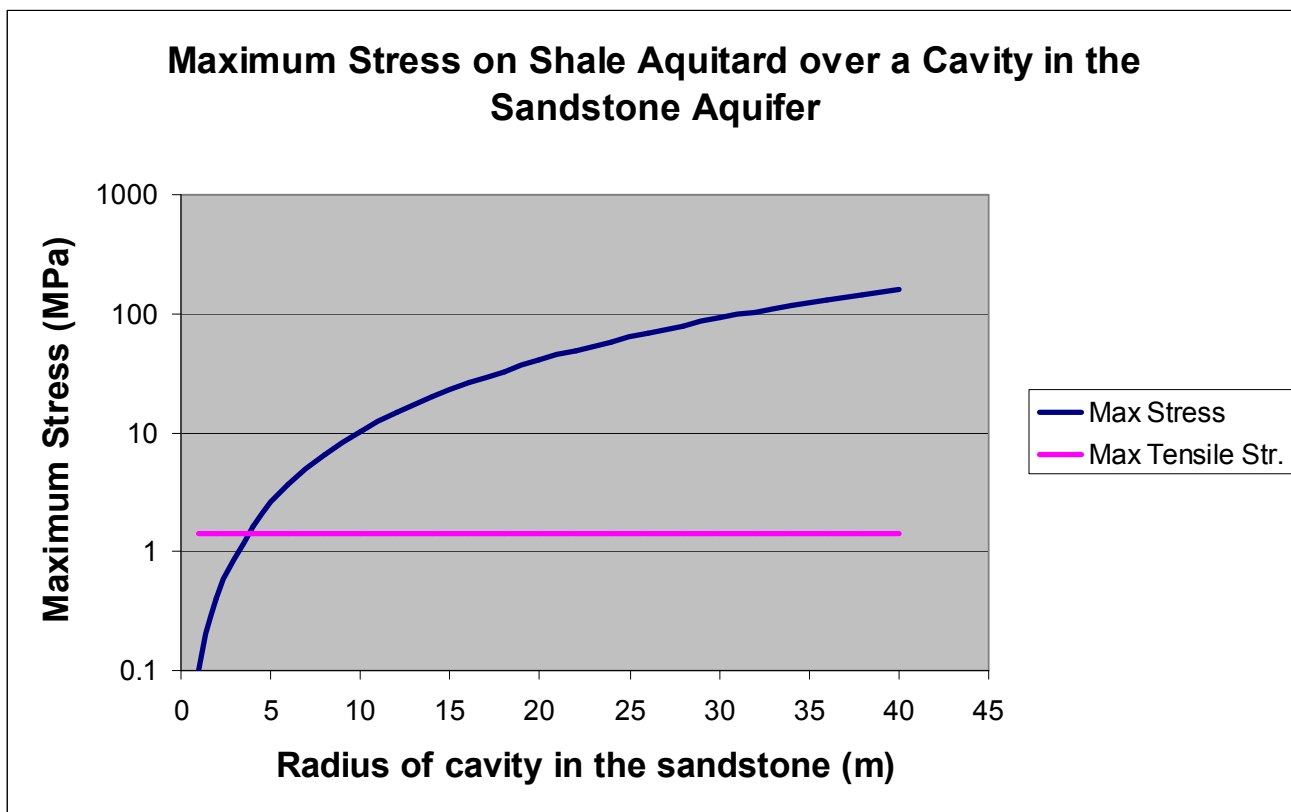
**Figure A5.** Maximum stress on the shale aquitard from the overburden pressure and maximum expected tensile strength of the shale aquitard.

Figure A5 illustrates the overburden stress on the shale aquitard would be expected to far exceed the tensile strength of the shale for a sandstone cavity radius of over 4 meters. The cavities will certainly exceed 4 meters in radius and will likely increase with time from sand slumping into the cavity. The process of slaking will also cause the shale aquitard to collapse into the cavity in the sandstone.<sup>49</sup>
