CNRL's Persistent 2013-2014 Bitumen Releases near Cold Lake, Alberta: Facts, Unanswered Questions, and Implications

Final Report (February 2014)

Kevin Timoney (Treeline Ecological Research) Peter Lee (Global Forest Watch Canada)

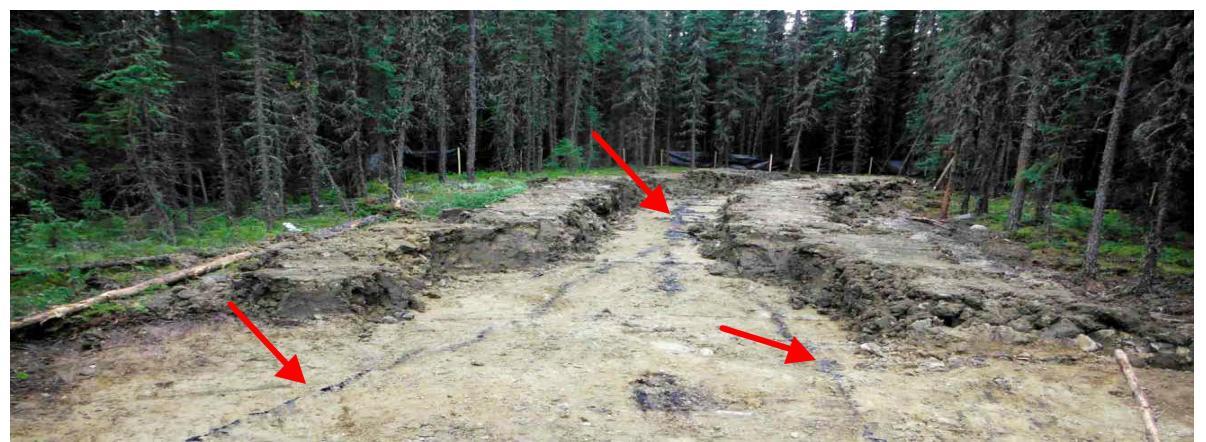
[This is the CNRL investor relations office. Why is a contact provided for media and not for the public?]
[The update provided a photograph of an excavation of a surface fissure at site "02-22". The caption read:] Exposed Fissure at 2-22

[Notes to accompany the image. This view of part of the excavation at the "02-22" release site reveals two bitumen-releasing fissures that converge near photo center (red arrows). The excavation trench cuts through an imperfectly-drained black spruce forest. The bitumen here is being released from a three-dimensional network of fissures, not from a single well bore. The three-dimensional spatial extent and volume of the bitumen releases below-ground have not been ascertained. Image modified after CNRL (2013 b).]

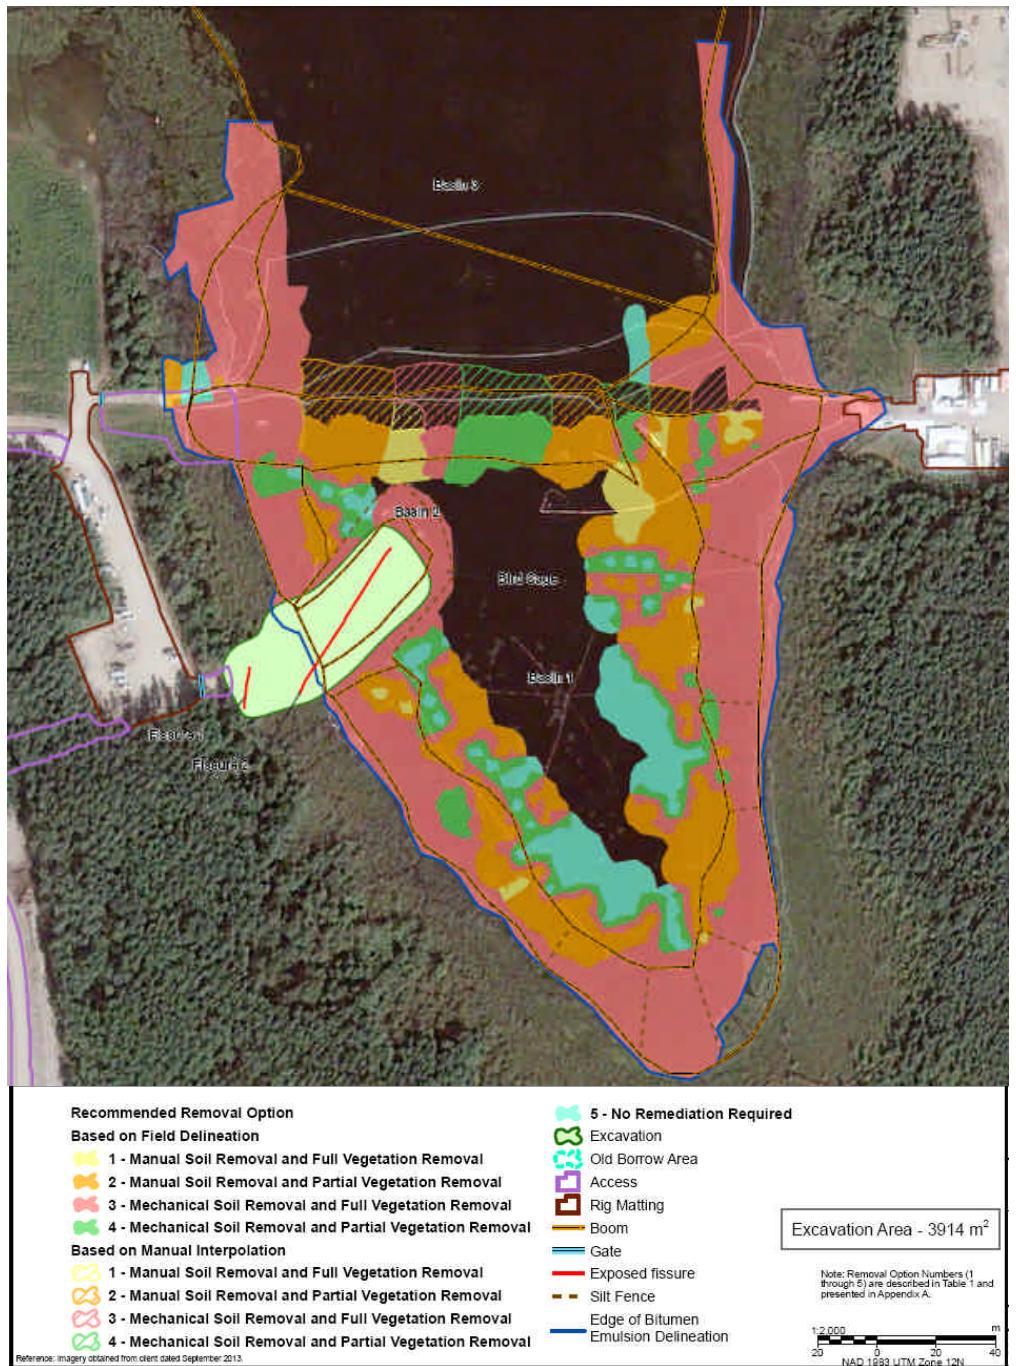
Figure 7. The south end of the 09-21 spill site. The blue line denotes the edge of the bitumen emulsion as delineated by CNRL. The yellow, orange, and green polygons denote the recommended removal options for contaminated soil and vegetation. The red lines on the west (left) of the 09-21 lake denote bitumen release fissures. Image modified from Figure 5 in CNRL (2013i).

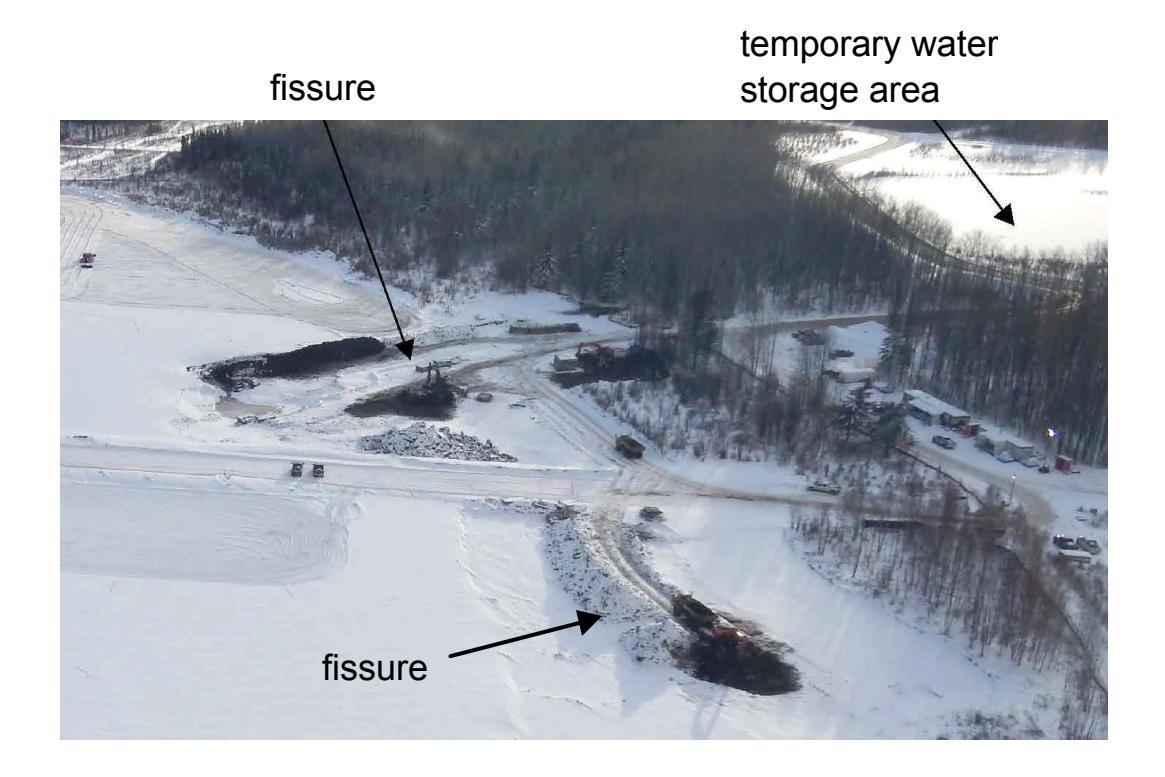
Figure 8. The two "suspected fissure" sites on the west side of 09-21 lake on 15 December 2013. Note the accumulations of black materials in the vicinity of the fissures. Image downloaded and modified from CNRL (http://www.cnrl.com; aerial-photograph-9-21-site-december-15-2013.jpg).

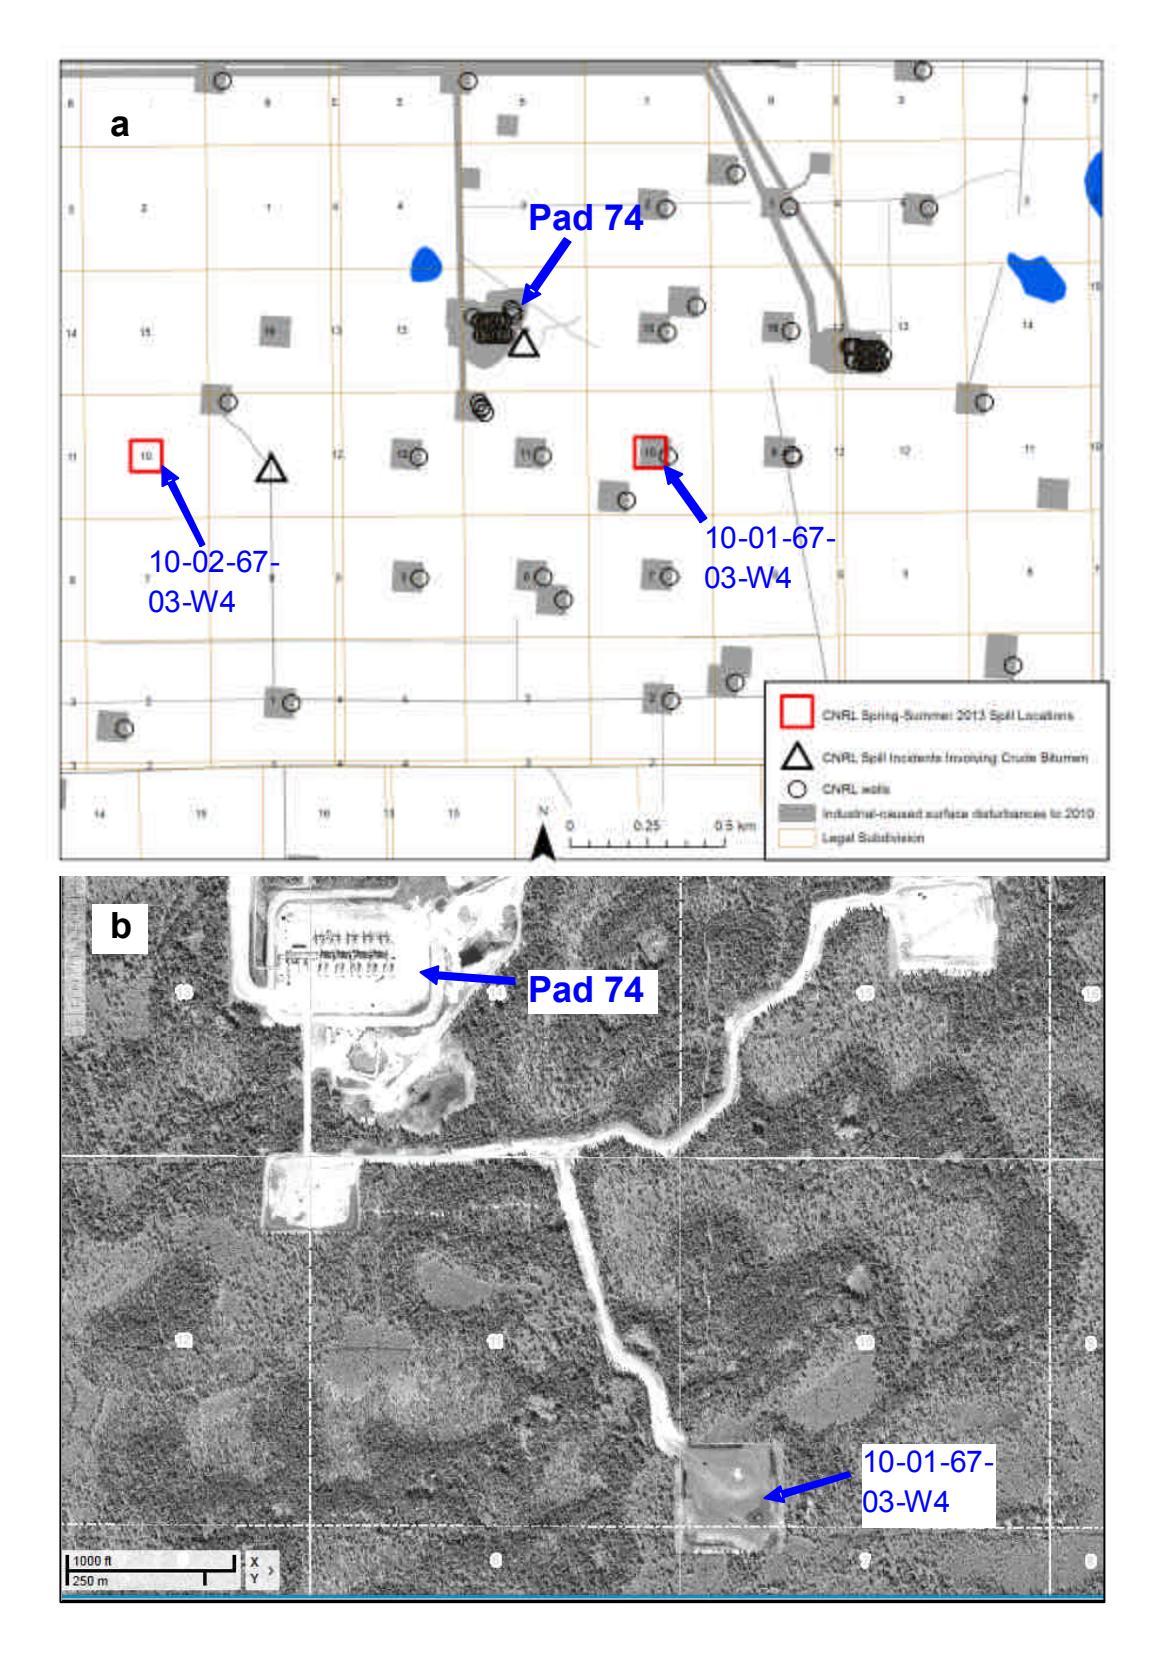
Figure 10. (a) Locations of two winter-summer 2013 CNRL bitumen releases (10-01-67-03-W4, 10-02-67-03-W4) in relation to CNRL Pad 74. The numbers in the center of each square are the LSDs. (b) Aerial view of the vicinity of the Pad 74 and 10-01-67-03-W4 bitumen release sites from an undated Government of Alberta image. Note the large scale of the images.
