CNRL's Persistent 2013-2014 Bitumen Releases near Cold Lake, Alberta: Facts, Unanswered Questions, and Implications

Final Report (February 2014)

Kevin Timoney (Treeline Ecological Research) Peter Lee (Global Forest Watch Canada)

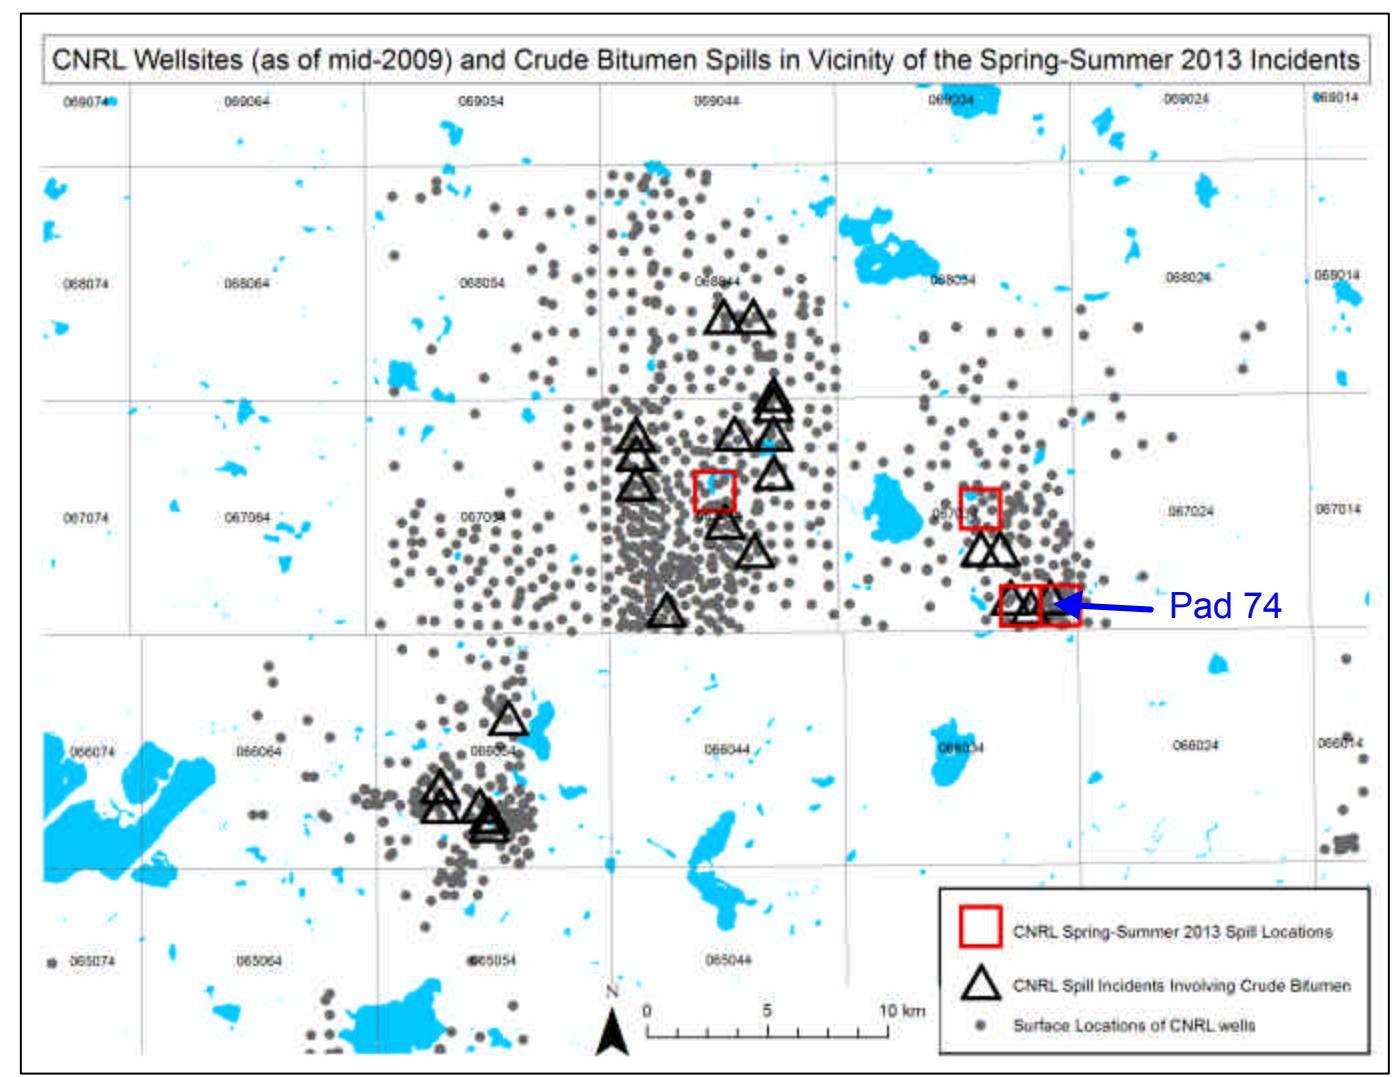
Figure 2. Locations of the four CNRL 2013-2014 ongoing bitumen releases, location of other CNRL spills from the ERCB (AER) spills database that occurred between 2003 and 2013, and the surface locations of CNRL wells in the Primrose study region. The six digit number in each box provides the Township, Range, and Meridian (for example, 067024 indicates Township 67, Range 2, W4). The location of the 2009 CNRL bitumen release at Pad 74 (ERCB 2011) is indicated.

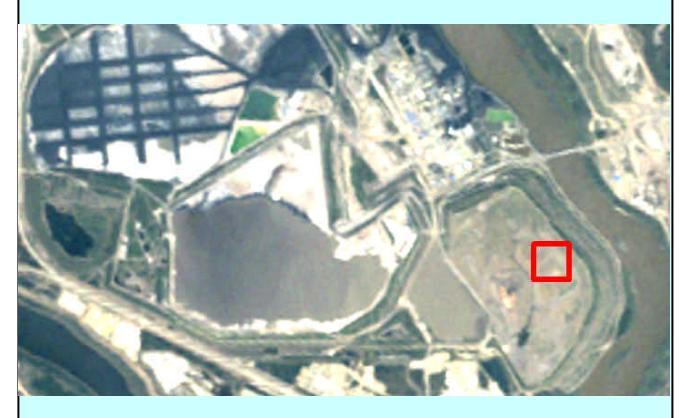
Box 1. Plotting of the largest reported bitumen release incident on record indicates that it occurred on the east side of Suncor's Tar Island Pond One (location shown as the red box in the image below).

Reference to the incident database compiled for the region (Timoney and Lee 2013) reveals a Suncor spill on that date that may correspond to the AER incident: "Spill of pond effluent water into pond and sump; probably not into the Athabasca River. Cause is due to pressure safety valve lifted" (AESRD incident number 221357). No evidence of enforcement action was found in relation to this largest of known bitumen releases. Incidentally, the location and date of the 3,000 m³ 2006 bitumen release were near and occurred just prior to Total's Joslyn project catastrophic blowout/cap rock failure which took place on 18 May 2006 at 15-33-95-12-W4 which was recorded by AER as the release of 5,000 m³ of process water.

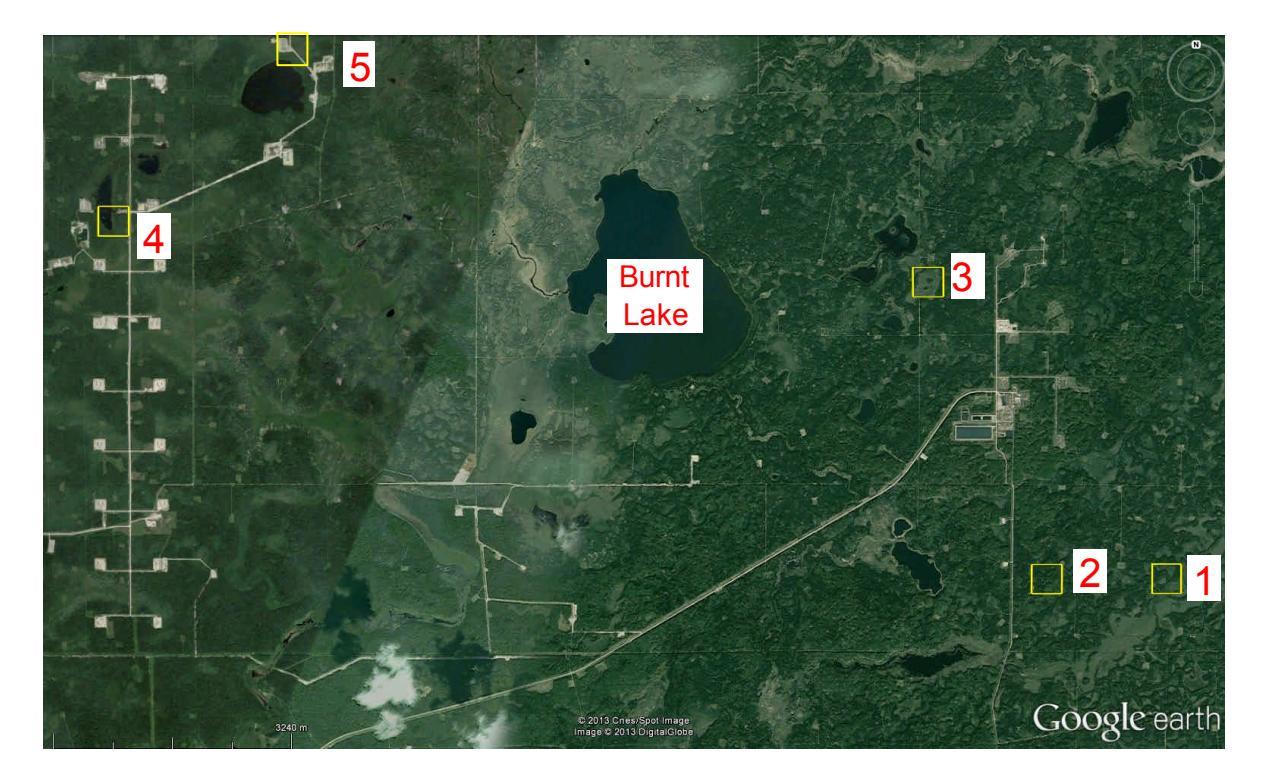
[There are four affected areas, not one, and at each site, water would have been affected because all four sites are located within wetland complexes (Figures 3 and 4). Secondly, the affected waterbody at release site 09-21-67-04W4 is a 50.3 ha lake, not a slough (Figure 4, panels d, e). The 31 July 2013 CNRL press release states that this lake is a "shallow slough that does not flow in or interact with other water bodies". Detailed aerial imagery released in December 2013 (CNRL 2013i) indicates that water flow in the spill site 4 peatland complex is towards the south then west into the Wolf River (see Figure 3, upper left corner).]

Figure 3. Locations of the 2013-2014 CNRL bitumen release sites within the context of the local landscape, which is predominantly a bog and fen peatland complex, as plotted on a Google Earth mosaic constructed from images taken on 19 June 2005 and 7 July 2005. 2013 Locations: (1) LSD 10, Sect. 01, Twp 67, Rge 03, W4; (2) LSD 10, Sect. 02, Twp 67, Rge 03, W4; (3) LSD 02, Sect. 22, Twp 67, Rge 03, W4; and (4) LSD 09, Section 21, Township 67, Range 04, W4. (5) LSD 03, Sect. 35, Twp 67, Rge 4, W4; this is the January 2014 CRNL bitumen release, AER incident number 20140048 (location provided by M. Darwent, AER, 28 January 2014). Pad 74, the site of the 2009 bitumen release, did not exist in 2005; it is located in LSD 14, Sect. 01, Twp 67, Rge 03, W4, ~ 700 m northwest of site (1); for the location of Pad 74, see Figure 4.

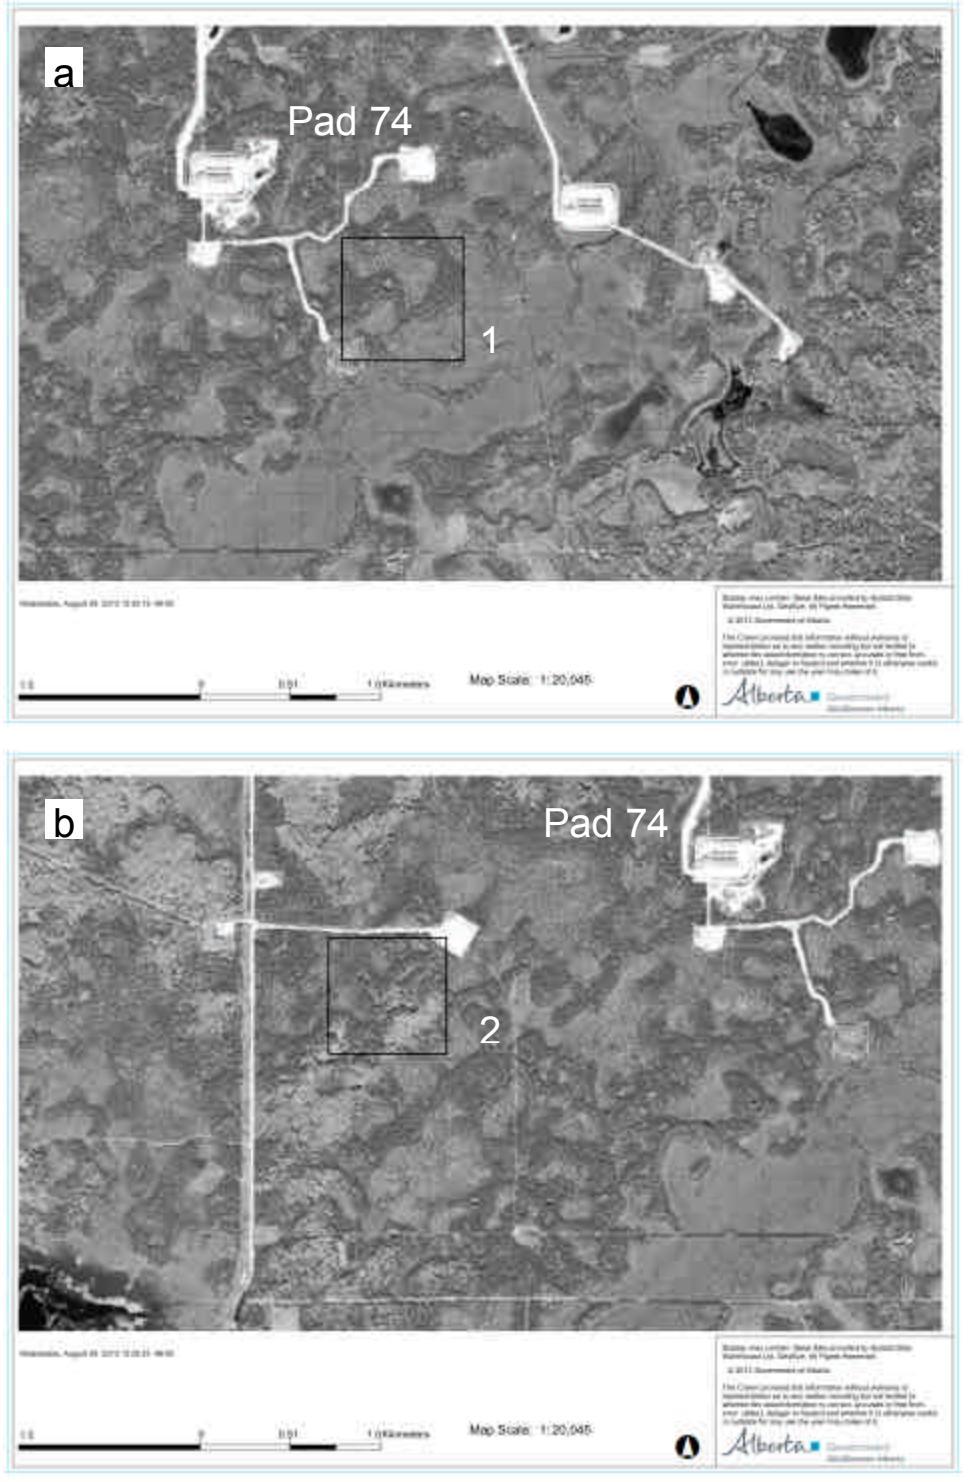
Figure 4. (a) CNRL spill site 1 (10-01) and (b) spill site 2 (10-02), delimited by black squares. Positions are based on legal locations provided by AER. Note the proximity of CNRL Pad 74.

Figure 4, continued. (c) CNRL spill site 3 (02-22) and (d) spill site 4 (09-21), delimited by black squares. Positions are based on legal locations provided by AER.

Figure 4, continued. (e) Oblique aerial view of spill site 4 (the 09-21 site). Image modified from CNRL (2013e); image date was not provided. The inset in the lower right is from a September 1987 false colour Landsat image (the yellow box indicates the legal location of the 09-21 spill site). Desiccation of the 09-21 lake post-1987 is evident as is the increase in landscape disturbance over the period. The placement of the well pad directly within the wetland drainage channel would have modified the local hydrology. The "storage area (pit)" was formerly a natural wetland. According to AER correspondence (4 October 2013), there is no well associated with the 09-21 bitumen release site.

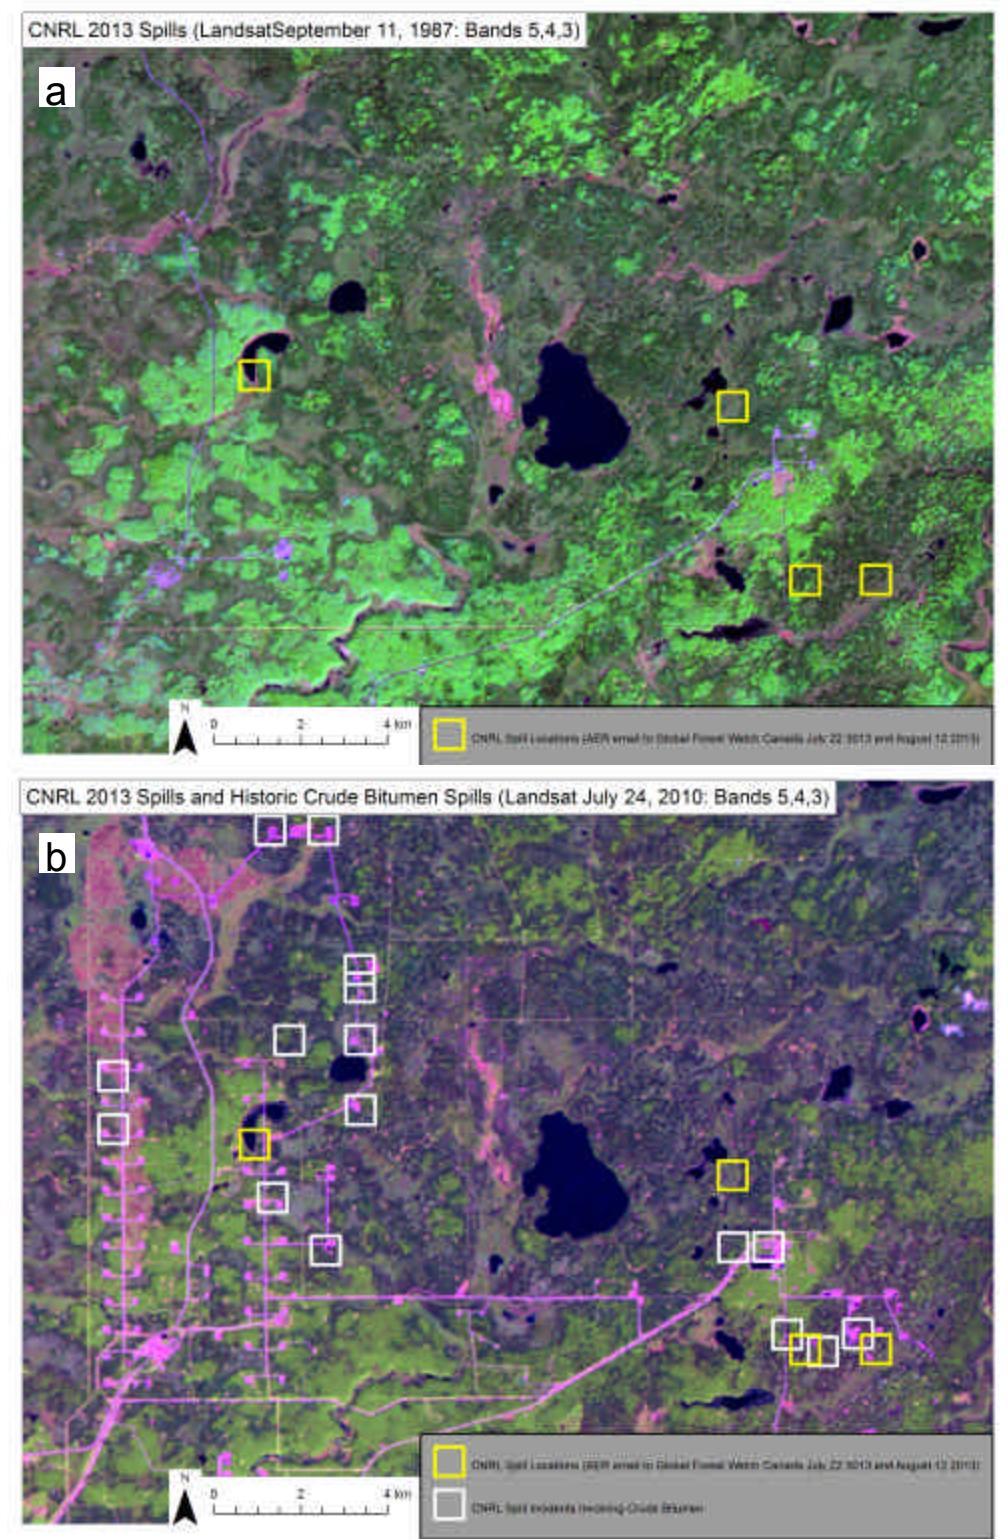
[The statement that there have been few releases of bitumen emulsion to the surface merits scrutiny. Examination of the regulator's spill database for the CNRL operations in the Primrose area documented 36 releases of bitumen between April 2003 and January 2013 (Table 1a, Figure 5). That list does not include the four recent releases of bitumen in 2013 that are the focus of this bulletin.

Figure 5. False-color infra-red satellite images of (a) the area of the four 2013 bitumen releases (yellow boxes) in September 1987 and (b) the area in July 2010. Other bitumen releases attributed to CNRL in the area near the 2013 releases are plotted (white boxes) based on the ERCB spills database. The increase in landscape disturbance over the 26-year period is significant.

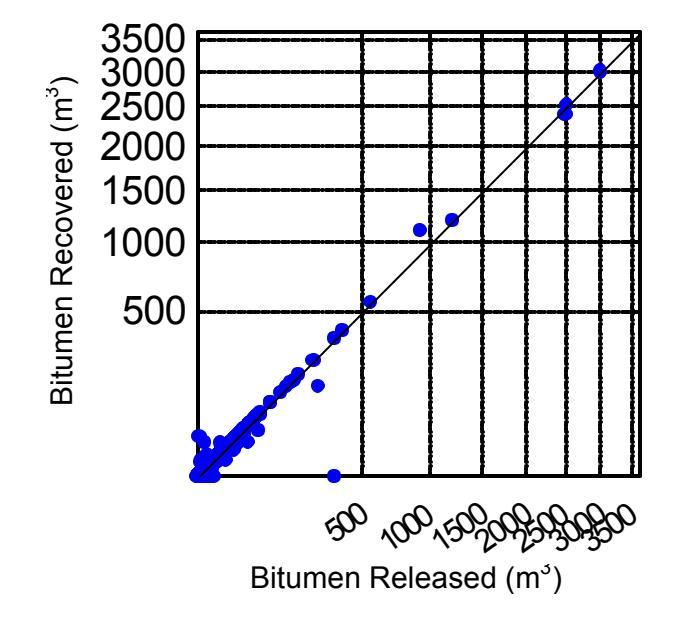
Figure 6. Relationship between crude bitumen released and recovered based on ERCB release data. The diagonal line depicts a perfect 1:1 relationship between volume released and volume recovered. Points above the line indicate that more bitumen was recovered than was released. Both the x and y-axes are power-transformed (power = 0.5) to better depict the lower values. There are 856 data points; hundreds of data points overlap.

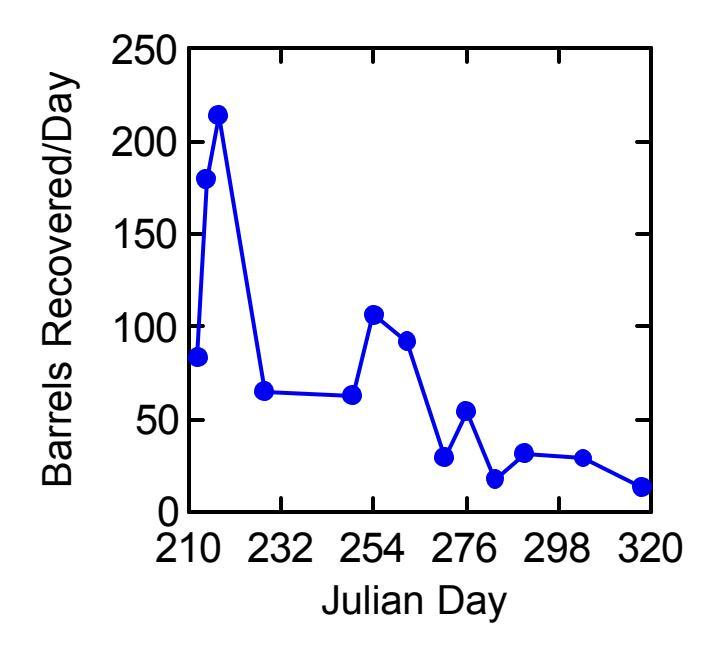
^ As of 14 November 2013, AER and CNRL reported a total of 1,878.62 m³ (11,802 barrels) recovered. As of 10 January 2014, CNRL reported to the authors that the total volume recovered had been revised to 1,864.21 m³. In contrast, as of ~ 19 January 2014, AER posted a total volume recovered, as reported by CNRL, of 1,177.14 m³. No explanation for these downward revisions and discrepancies has been provided by industry or AER. Nor do these values make sense in light of CNRL President Laut's statement (Reuters 2014) of 14 January 2014 in which he was quoted that the field was seeping at about "one cubic metre squared per day" [*sic*, m³/day] (or 6.3 barrels/day). If the 14 November 2013 total release value was correct, and the daily release value provided by the CNRL President is accurate, then the total volume released as of 14 January 2014 at the four CNRL sites should be roughly 1,939.6 m³ (12,185 barrels), or if the CNRL 10 January 2014 update was correct, then perhaps 1,925.2 m³.

Figure 9. Barrels recovered per day at the four CNRL release sites over the period late-July through mid-November 2013. Due to discrepancies in the total barrels recovered as reported in January 2014, no data points after 14 November 2013 are plotted. Data are derived from Table 2.
