## Evidence for Aquifer and Slurry Line Contamination and Land Subsidence From Vivian Silica Sand Extraction Wells

by D.M. LeNeveu, M.Sc. (biophysics), B.Ed., B.Sc. (hons. physics)  
February 2021  
Prepared for What the Frack Manitoba

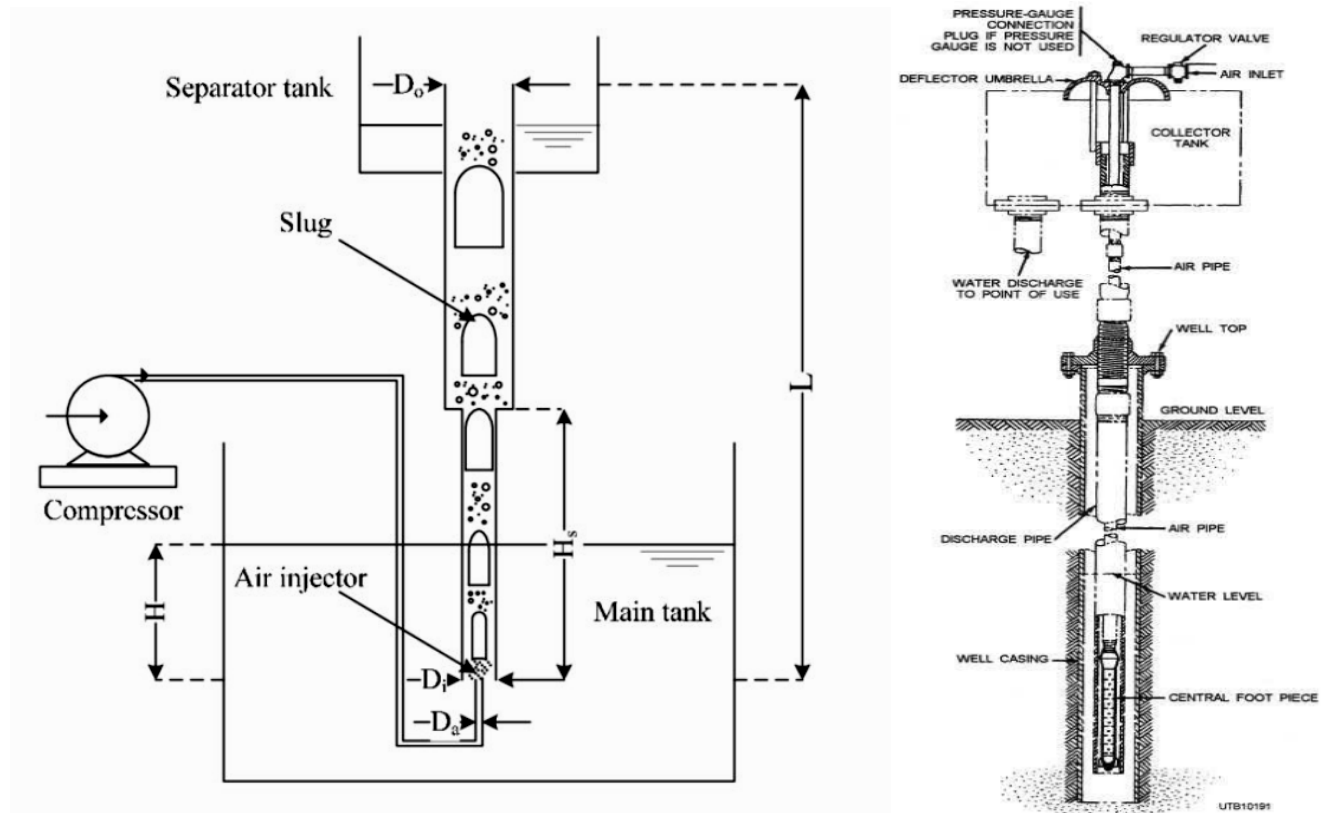
**Figure 4. a.** Schematic of a typical air lift pump from Hanafizadeh and Ghorbani, 2011<sup>16</sup> **b.** air lift pump showing central air tube and foot piece for air dispersion<sup>17</sup>.

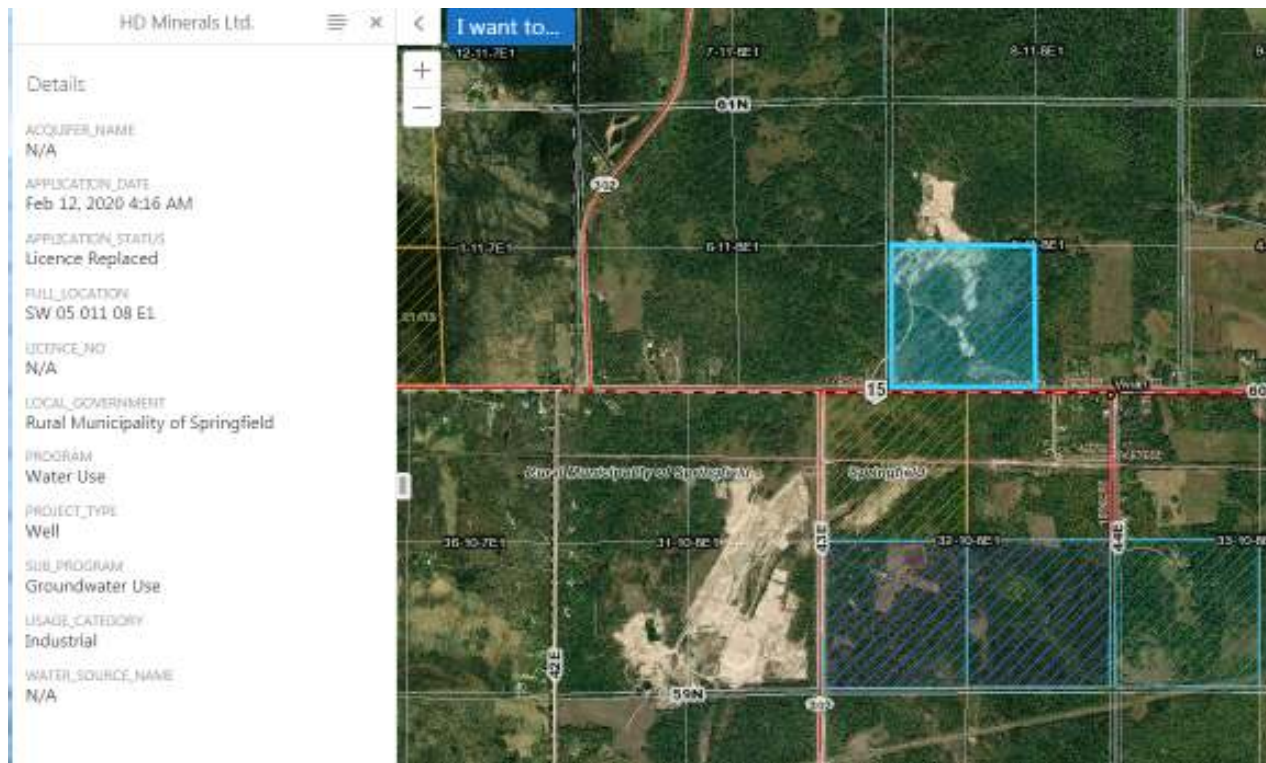
**Figure 15.** Temporary authorizations for water use at a quarry in township SW05-11-8E north east of Vivian and water authorisation permits for SE32-10-8E south of Vivian. Sand extraction occurred at both sites.

Excess water from sand extraction at the quarry of Figure 15 would have been discharged on the surface or injected into the formation or both. Discharge of contaminated water onto the surface of a quarry would quickly migrate down through the permeable sand and gravel of the quarry toward the carbonate aquifer. It is inconceivable that up to 28,800 cubic meters of water withdrawn from the quarry as shown in Table 2 would have been discharged. Residents did not notice a large amount of surface discharge. Much of the water extracted with the sand water would have been likely pumped into the carbonate aquifer as evidenced by the triple tube air lift well construction at Centre Line Road. There are no available well records for this site.

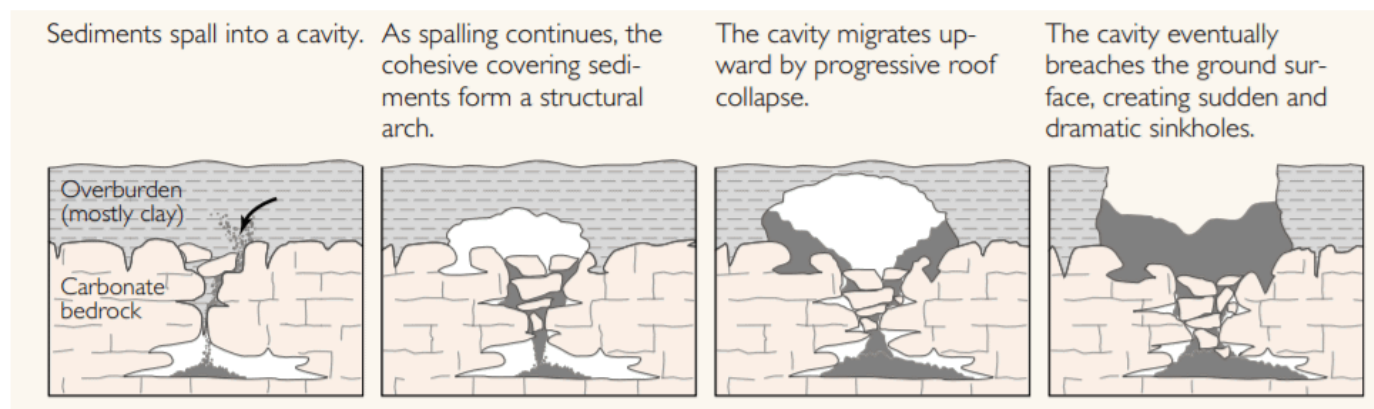
fractures in limestone layer in to a cavity below. This is termed cover collapse sinkholes. These two mechanisms for subsidence are illustrated in Figure 17 and Figure 18. Figure 17 and Figure 18 do not show a shale aquitard above the cavity. The shale aquitard will have likely collapsed into the cavity from the overburden pressure and slaking.<sup>49</sup> Figure 17 and Figure 18 are therefore applicable to the CWS operations. Glacial till containing clay or a mixture of sand and gravel would overlie the limestone as documented in the 42 core logs for CWS wells. The CWS core logs show glacial till is most common therefore cover collapse sinkholes would be expected to predominately occur.

**Figure 18.** Cover collapse sinkhole into a cavity in limestone. The image is from USGS.<sup>23</sup>

The formation of sinkholes can be accelerated by acidic groundwater such as from pyrite oxidation and from increased aquifer flow from water injection.<sup>23</sup> The limestone is about 80 feet thick at the Centre Line Road site but only about 30 feet thick at the Vivian site at township SW32-10-8E. Sinkholes are more likely to develop in the areas with a thinner limestone layer where the distance for downward piping of the till through vertical cracks is smaller. Sinkholes are found in the Springfield area.<sup>24,25</sup> From this evidence land subsidence into the cavities caused from sand extraction by CWS is almost certain to eventually occur. Given the large number of CWS wells to be drilled per year the resulting subsidence will be a serious problem over a large area. The mine closure report required under the Manitoba Mines and Minerals Act would have quantified the risk of land subsidence. The closure plan and financial assurance would have addressed rehabilitation measures for subsidence.

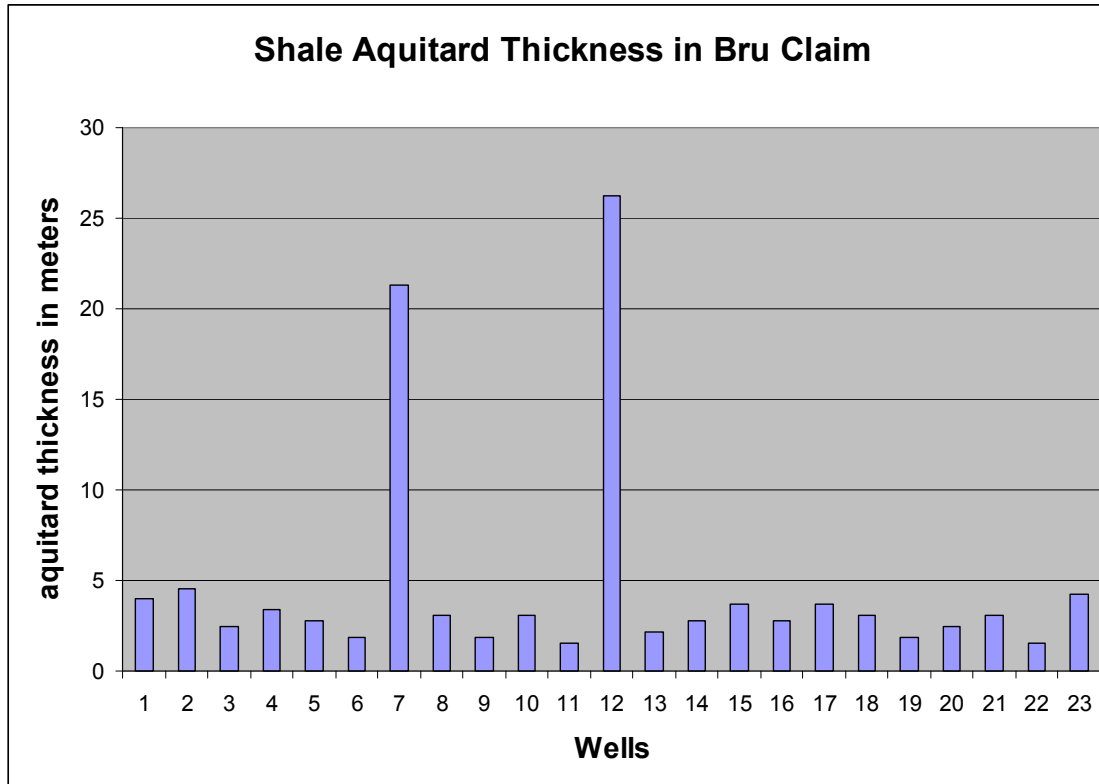
for CanWhite wells obtained from Manitoba Groundwater the overburden thickness of soil/till/gravel is usually about 25 meters. The carbonate aquifer is about 20 m thick. The shale aquitard varies in thickness from about 2 to 5 meters as shown in Figure A1. There are two anomalously thick samples of the shale aquitards that can be attributed to a merging with shale lenses normally found further down in the aquifer. The average thickness of the aquitard in the Bru claim area is 2.83 m excluding the two anomalously thick samples. The dry density of the till and gravel overburden is about 2.0, the carbonate 2.5 and the shale 2.2 t/m<sup>3</sup><sup>48,51,52,53</sup>

**Figure A1.** Shale aquitard thickness in Bru claim area south of Vivian, Manitoba from CWS well information records

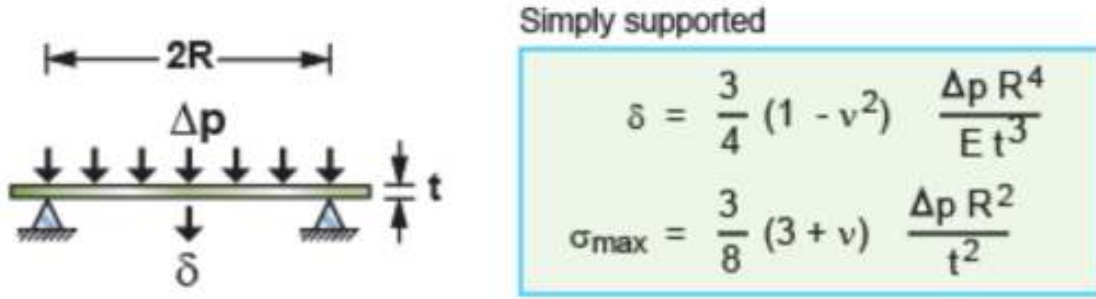
Figure A2 shows the relationships for the deflection  $\delta$  and the maximum stress on the disc due to a pressure from above  $\sigma$ .<sup>54</sup>

**Figure A2.** Maximum stress for a simply supported loaded shale aquitard layer

In Figure A2  $\nu$  is Poisson's ratio.  $R$  is the radius of the circular slab representing the unsupported aquitard suspended over the cavity in the sandstone.  $\Delta p$  is the pressure difference,  $t$  is the slab thickness,  $E$  is Young's modulus,  $\delta$  is the deflection and  $\sigma_{\max}$  is the maximum stress. As the circular shale slab deflects downward the under side will be under tension. The slab will break when the maximum strength exceeds the tensile strength along the bedding planes of the shale. Poisson's ratio is zero for a perfectly stiff material and has a maximum of 0.5 for a perfectly elastic material.<sup>56</sup> Shale will have a Poisson ratio of about 0.3.<sup>59</sup> The minimum radius of the unsupported circular slab of shale is 20 m. All that remains to determine the maximum stress is the pressure difference that will be given by,

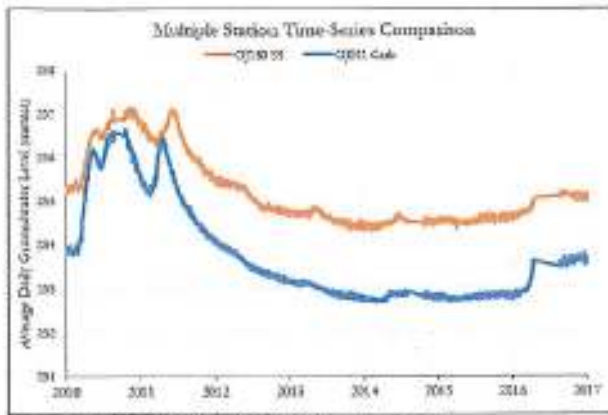
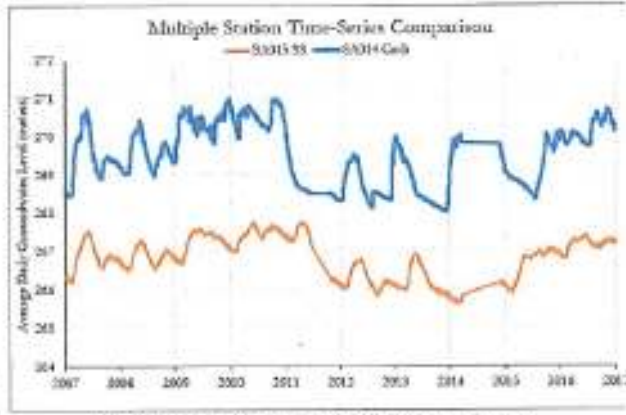
### Figure A3. Head difference between carbonate and sandstone aquifer

The head difference between the carbonate and sandstone aquifers varies with location. West of Vivian the sandstone aquifer head is higher than the carbonate but around the Vivian area the heads reverse as shown in Figure A3.<sup>50</sup>

Figure 11 – G05OJ011/G05OJ180 comparison

Figure 12 – G05SA015/G05SA014 comparison

Note that the OJ011/OJ180 station is located near Dugald, while the SA015/SA014 station is located near PTH 302. The sandstone level is shown in orange, while the carbonate aquifer level is shown in blue. (data source – MSD, 2015)

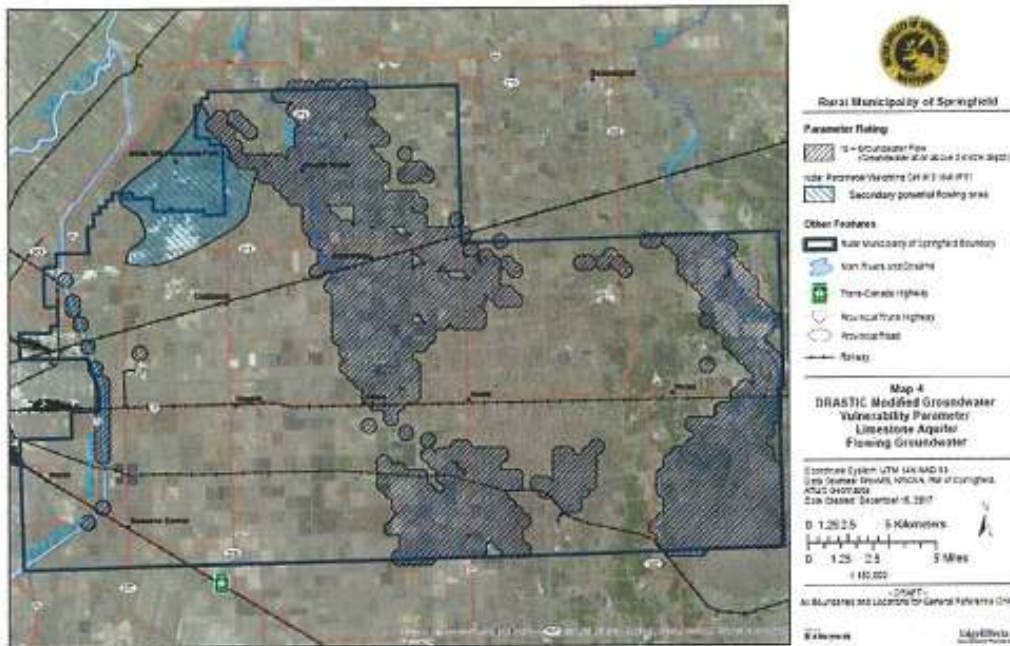
Figure 30 – Flowing groundwater areas in the carbonate aquifer throughout the RM of Springfield; modeled from hydrograph and LIDAR topography data; Secondary potential flowing area is based off of topographical data, is approximate and will vary locally. (data source – MSD)

### Figure A4. Areas of flowing groundwater in Springfield, Manitoba from Friesen Drillers<sup>50</sup>

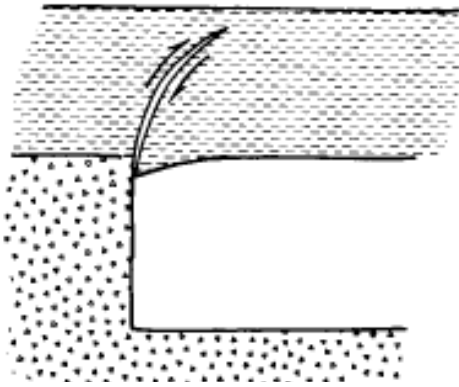
The shale layer over the cavity might also fail due to maximum shear stress at the edge as show in Figure A6

**Figure A6.** Shear stress at edge of a roof over a cavity from Goodman (1989)<sup>48</sup>

The equation for the maximum shear stress  $\tau_m$  at the edge of a circular disc is  $\tau_m = 3\Delta p R^2 / (4t^2)$ .<sup>61</sup>
